PERFORMANCE OF ESSENTIAL FACILITIES IN THE 2012 VARZAGHAN-AHAR EARTHQUAKES

Tariq MAHDI

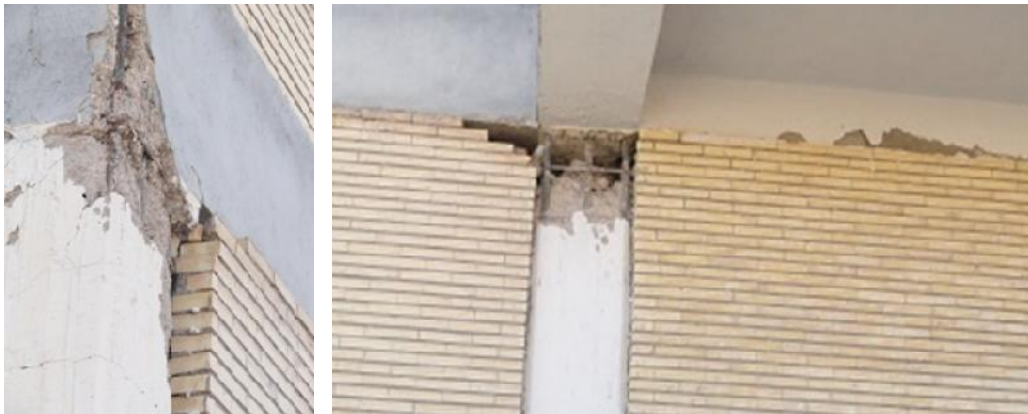
Figure 1. Shear cracks and plastic hinges in columns and cracks in beams due to the presence of infill walls

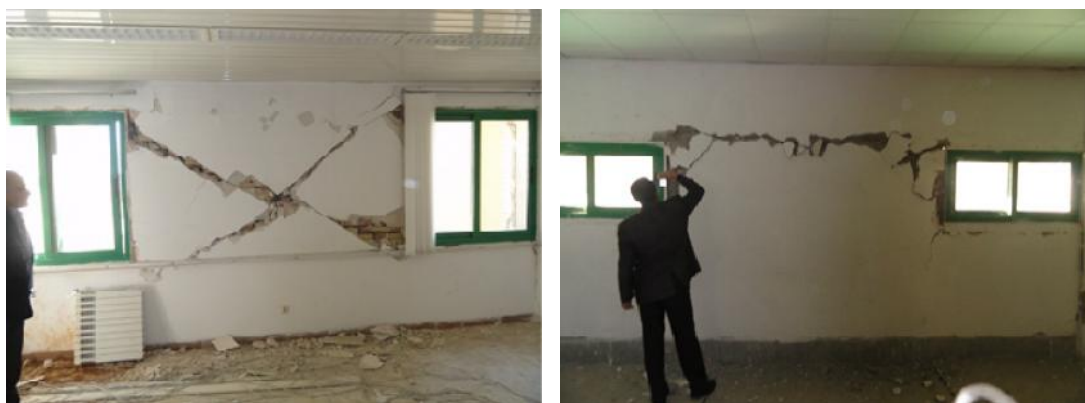
Figure 2. Typical cracks in structural infill walls

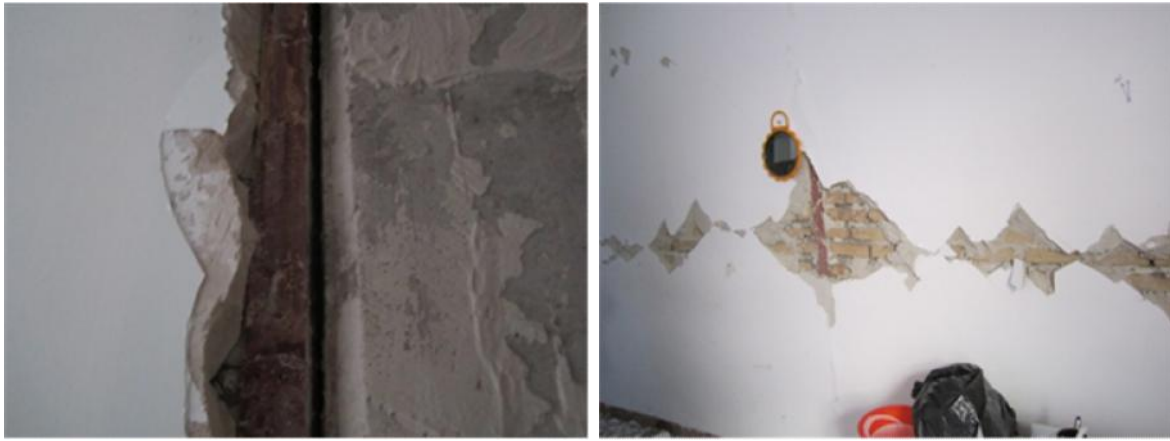
Figure 3. Double angles at the edge of non-structural infill wall (left) and spall of plaster at the middle of infill wall showing the mid-span angles used there (right) (Consulting Engineers of Fadak, 2013)

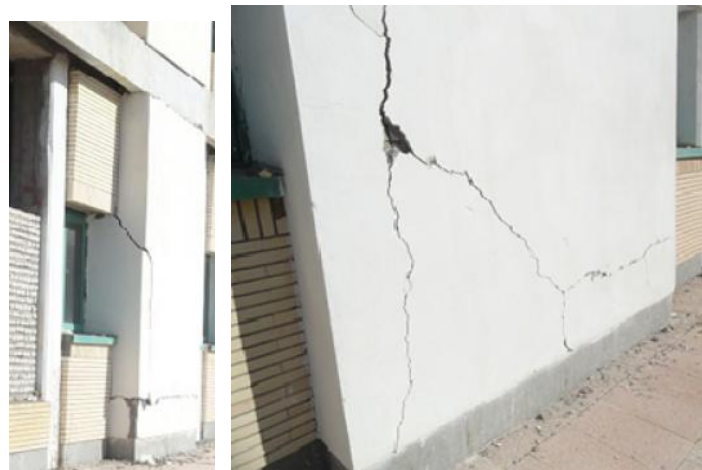
Figure 4. Typical cracks in non-structural external walls

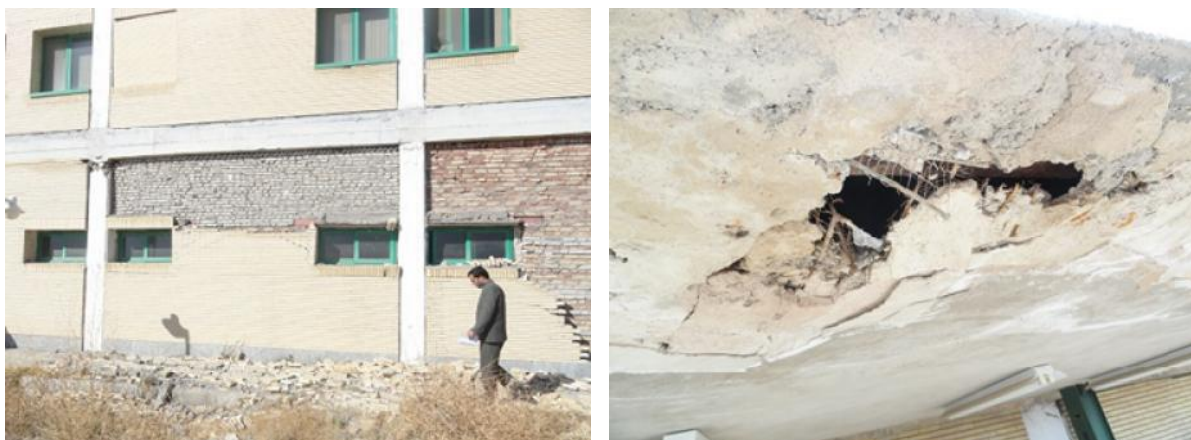
Figure 5. Failure of façade (left), and failure of metal meshes coated by plasters in a suspended ceiling (right)

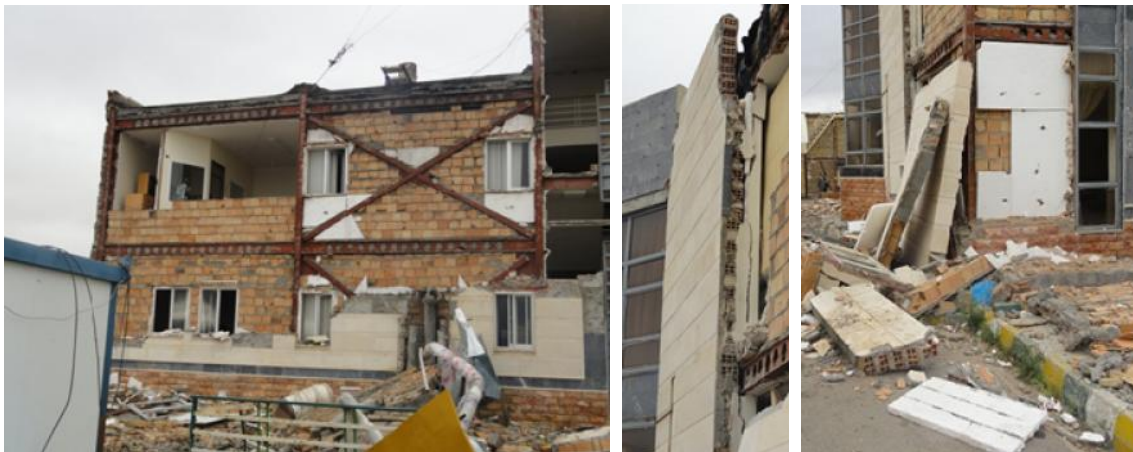
Figure 6. Collapse of infill walls and failure of façade due to out-of-plane forces (left), and failure of façade caused by in-plane forces due to improper connections to the back wall (middle and right)
